# National Transportation Safety Board

## Safety Recommendation

Date: June 16, 2000

In reply refer to: A-00-32 through -40

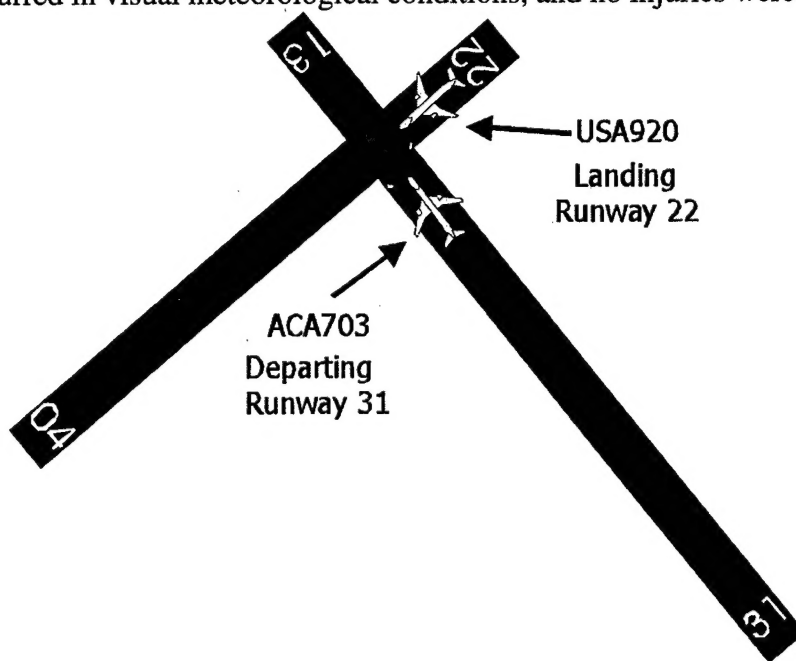
Figure 1. Approximate aircraft orientation for April 3, 1998, near midair collision (NMAC) at LGA

At the time of the incident, aircraft landing at LGA were using runway 22 and departing aircraft were using runway 31. Runway 22 intersects runway 31 approximately 5,300 feet from the threshold of runway 31. According to the LGA tower local controller, USA920 was executing a visual approach to runway 22 and had been cleared to land. The local controller then cleared ACA703 for takeoff from runway 31. Approximately 30 seconds later, he reassessed the traffic situation and decided that ACA703 would not clear the intersection before USA920 crossed the threshold of runway 22.<sup>1</sup> The local controller then instructed USA920 to go around.<sup>2</sup> ACA703 was airborne and climbing before it reached the intersection with runway 22; consequently, USA920 and ACA703 were in the air when their paths crossed. The captain of USA920 saw ACA703 on his left and alerted the first officer, who was flying the airplane. The first officer immediately took evasive action to avoid a collision. Radar data were not available because both airplanes were below radar coverage at the time of the incident; however, in the NMAC report he filed with the FAA, the captain of USA920 estimated that his aircraft passed 85 feet below ACA703 with horizontal separation of 75 feet. The local controller estimated the separation distance at 20 feet.

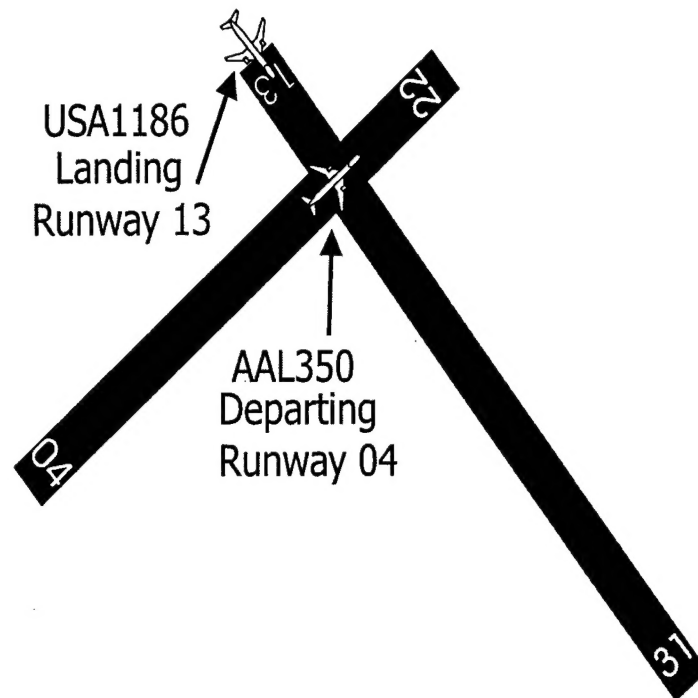
On January 23, 1998, about 1819 eastern standard time, US Airways flight 1186 (USA1186), a Boeing 737, and American Airlines flight 350 (AAL350), a McDonnell-Douglas MD-80, nearly collided at the intersection of LGA runways 4 and 13 (see figure 2). The reported weather was ceiling 600 feet and visibility 2 miles. According to an NMAC report filed by the captain of USA1186, his aircraft was on a 2.5 mile final for an instrument landing system approach to runway 13 when the local controller cleared AAL350 for takeoff from runway 4. The USA1186 captain reported that AAL350 did not pass through the intersection of runways 4 and 13 until after USA1186 had crossed the runway 13 threshold. The runway 13 threshold is 1,700 feet from the intersection with runway 4 or 7.5 seconds flying time at an estimated approach speed of 135 knots.

Figure 2. Approximate aircraft orientation for January 23, 1998, NMAC at LGA

The captain of AAL350 stated that he looked to his left as his aircraft passed through the runway 4/13 intersection and saw USA1186 approximately over the runway 13 threshold. Recorded air traffic control (ATC) communications indicate that after departure, one of the pilots of AAL350 said to the local controller, "that was close."

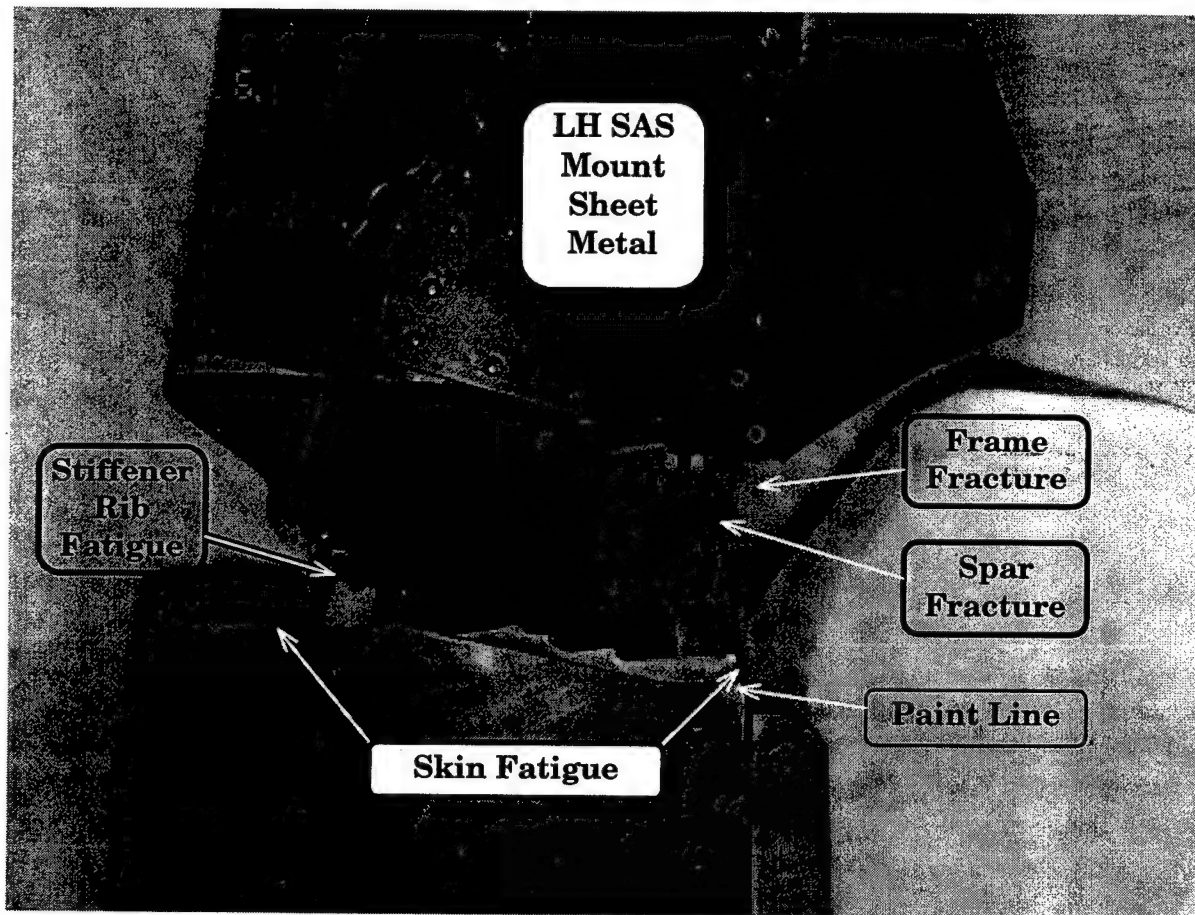
Metallurgical examination of the wreckage established that the separation was caused by fatigue cracking in multiple components of the vertical fin structure, including the skin and spar. Fatigue cracking was discovered at five locations in the vertical fin skin beneath the lower edge of the left-hand yaw stability augmentation system (SAS) servo mount support.<sup>3</sup> Fatigue cracks were also discovered in the vertical fin spar, which in effect partially severed the spar immediately adjacent to the noted skin cracks. The fatigue cracking in the skin originated at rivet holes common to the yaw SAS servo mount support and grew undetected to a length of approximately 5 1/2 inches before the ultimate separation of the vertical fin. The fatigue crack propagation in the skin was concealed by the installation of the yaw SAS servo mount support (see figures 1 and 2).

Figure 1. A left-side view of the fatigue area with the individual component fractures denoted. "Paint Line" arrow denotes the original position of the lower edge of the left-hand sheet.

The National Transportation Safety Board determines the probable cause(s) of this accident was:  
Fatigue failure of the vertical fin, accelerated by the installation of blind rivets in lieu of solid rivets in the replacement of the yaw SAS mount support, which resulted in the loss of helicopter directional control and collision with the terrain (water). Factors contributing to the accident were: a lack of information regarding repair of the yaw SAS mount support in the manufacturer's maintenance manuals, and the design of the vertical fin which was susceptible to fatigue cracking. An additional factor was the lack of an adequate passenger briefing.

Perform a fatigue evaluation/damage tolerance analysis of the Eurocopter BK117 vertical fin structure to ensure that the inspection requirements of Airworthiness Directive (AD) 98-24-13 are adequate to detect crack growth in the underlying areas of the modified spar and leading-edge skin and to verify that the BK117 vertical fin spar is not susceptible to fatigue failure beyond those areas specifically identified by AD 98-24-13. If the susceptibility is not so limited or the inspection requirements are not adequate, the AD should be superseded to ensure that all fatigue cracks will be detected. (A-00-46)

Issue a maintenance alert to all certificated airframe mechanics and inspectors to notify them of the circumstances of this accident and to inform them of the hazards associated with the installation of blind rivets. (A-00-47)

Revise 14 Code of Federal Regulations Part 43, Appendix A to state that repairs involving the substitution of fastener types are considered major repairs. (A-00-48)

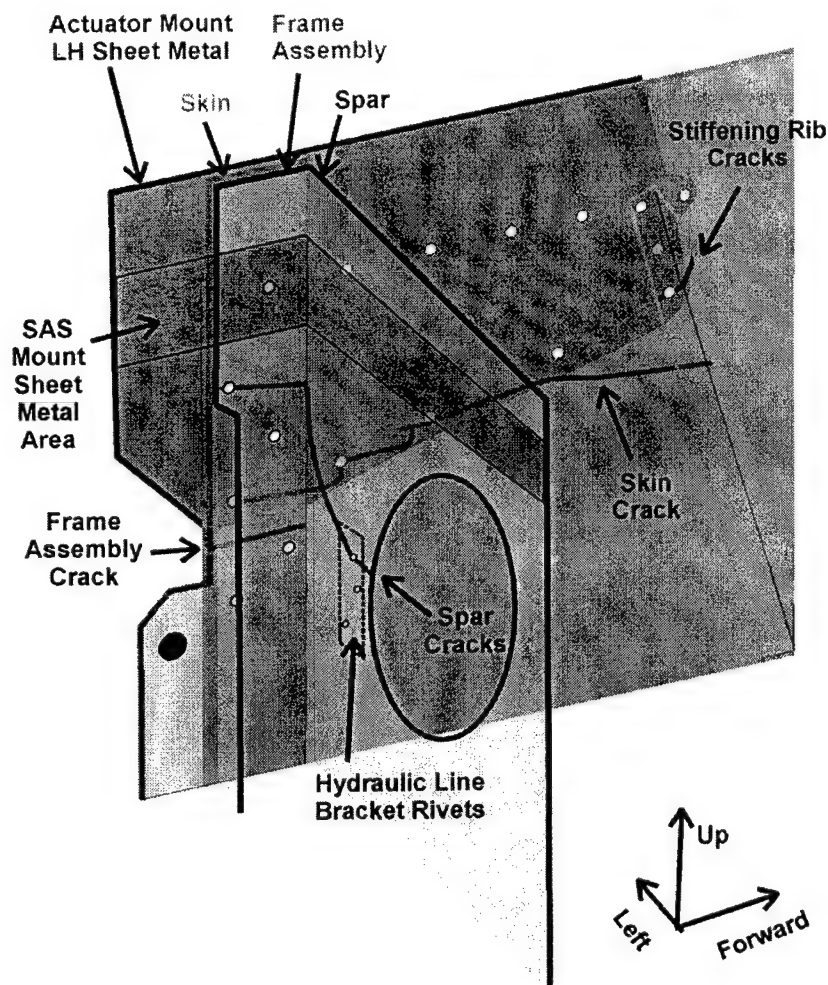
Figure 2. An illustration of the fin components in the area of the preexisting cracks. Of particular interest are the relative positions of the cracks in each member. Overlapping members are shown partially transparent to expose hidden detail. (Not to scale.)
